Rockwell Contractors Inc.

EIFS Moisture Inspection Report

1318 White Oak
Murfreesboro, TN 37130

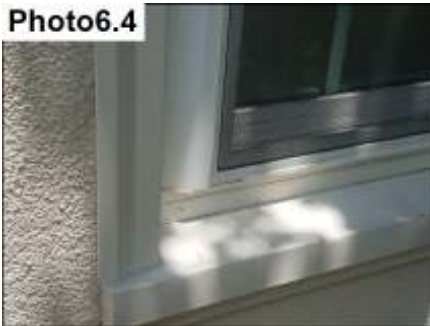
Photo6.4

this a photo of the typical metal cladding over wood windows.

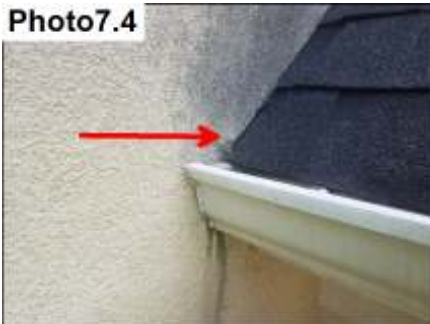
Kickout should be installed here.

A kickout flashing needs to be installed over the front entrance.

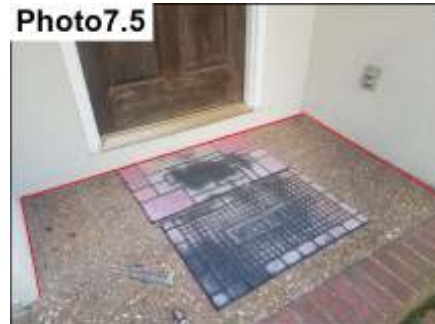
Porch needs caulking, theshold needs caulking and electrical socket

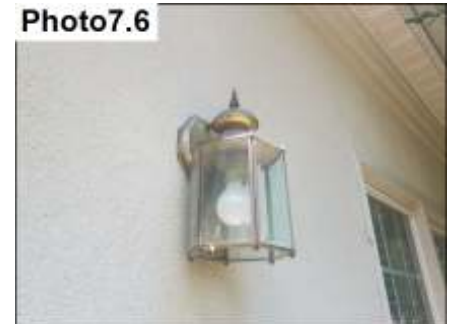
All lights need caulking.

Touch up caulking needs to be completed on some of the window with elevated readings. All lights, hose bibbs, and utilities need to be caulked.

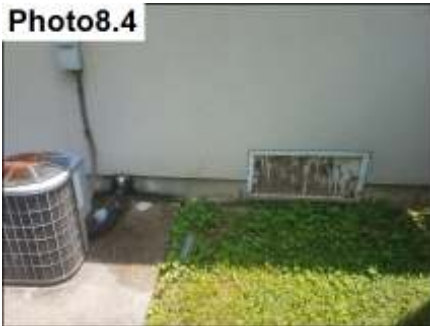
Photo8.4

Crawlspace door needs to be caulked.

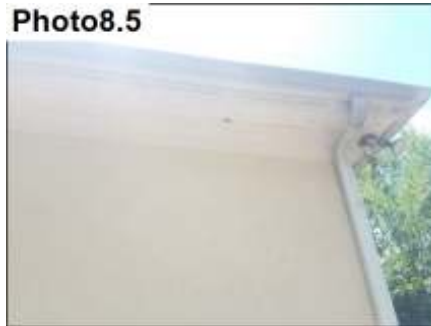
Photo8.5

Bird hole needs to be repaired.(J4)

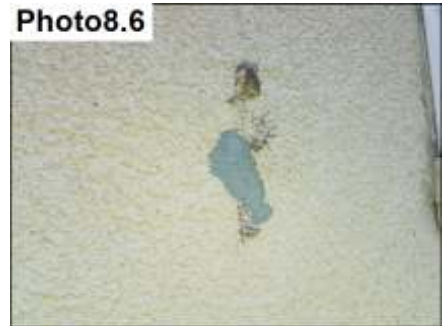
Photo8.6

Finish need to be added to this chipped area.(G5)

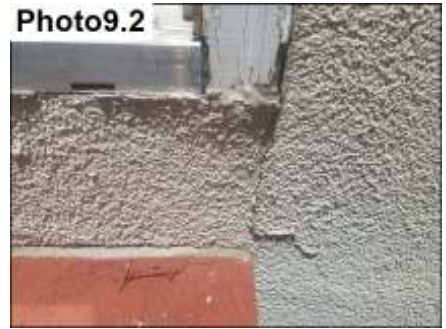
Crack notice below door. Needs repair.

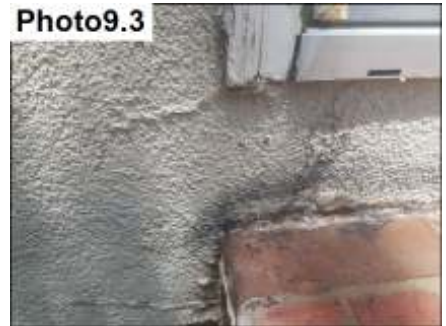
Area below door is delaminated and needs repair.

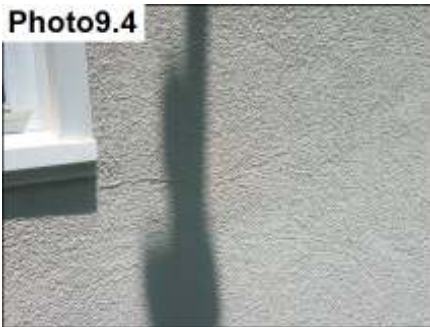
Small Crack at J5.

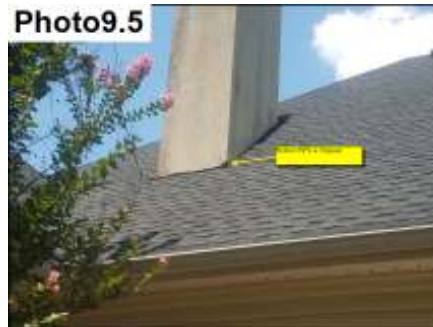
Bottom of chimney needs repair.

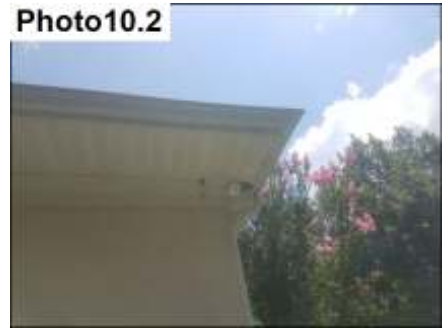
Bird Hole at J4.

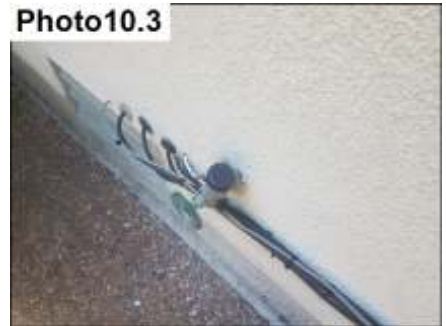
Hose bibbs need caulking.

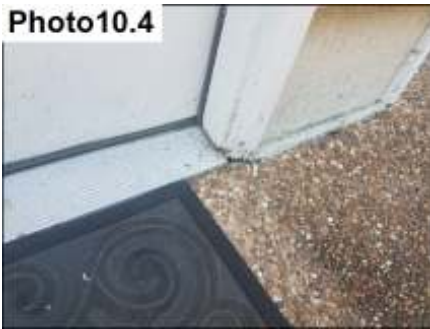
Brick mold at bottom of door needs replacing.

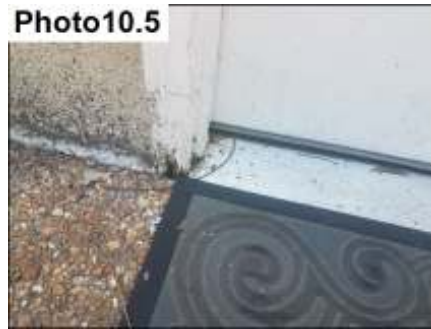
Brick mold at bottom of door needs replacing.

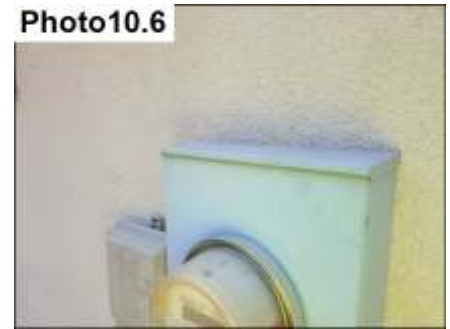
Utility boxes need caulking.
